<b>NUMBER OF PARTNER:</b>	P3 Cesmar7, P4 An.t.a.res srl
<b>TYPE OF WORK:</b>	Mural painting
<b>COUNTRY:</b>	Italy
<b>CITY:</b>	Reggio Emilia
<b>ADDRESS:</b>	Community Centre ARCI PIGAL Via Petrella
<b>OWNER / CUSTODIAN:</b>	Municipality of Reggio Emilia
<b>ARTIST:</b>	Göla Hundun
<b>TITLE OF THE WORK:</b>	Two dragons carrying a new creature OBJ_8
<b>YEAR OF EXECUTION:</b>	2012
<b>MATERIALS:</b>	Housepaint and spray

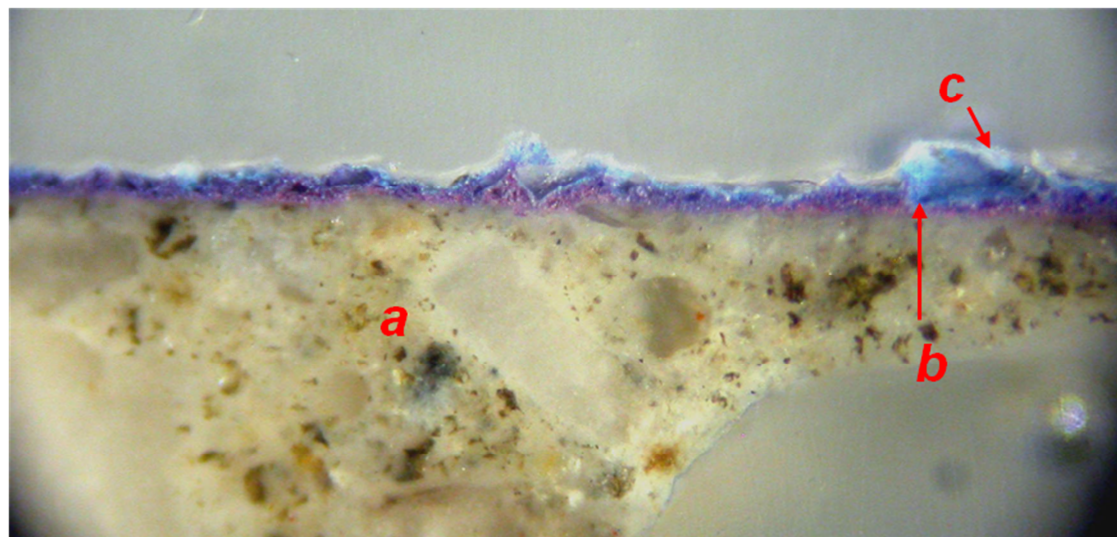
**Fig. 1** “Two dragons carrying an egg (new creature)” – sample GP1 – cross section – reflected Visible light – magnification 150 x

GP1 sample was collected from a blue area painted by brush (**fig.1**), that hue was originally deeper.

The study of the GP1 sample has shown the following structure and composition:

- a)** Concrete support > 500  $\mu\text{m}$  thick;
- b)** Violet paint layer based on phtalocyanine pigment, average thickness of 20  $\mu\text{m}$ ;
- c)** Bluish paint layer composed of Hostopen Violet, average thickness of 20  $\mu\text{m}$ ;
- d)** Whitish thin layer (coating) is hypothesized, it is too thin to be measured but its application has been reported by Pigal.

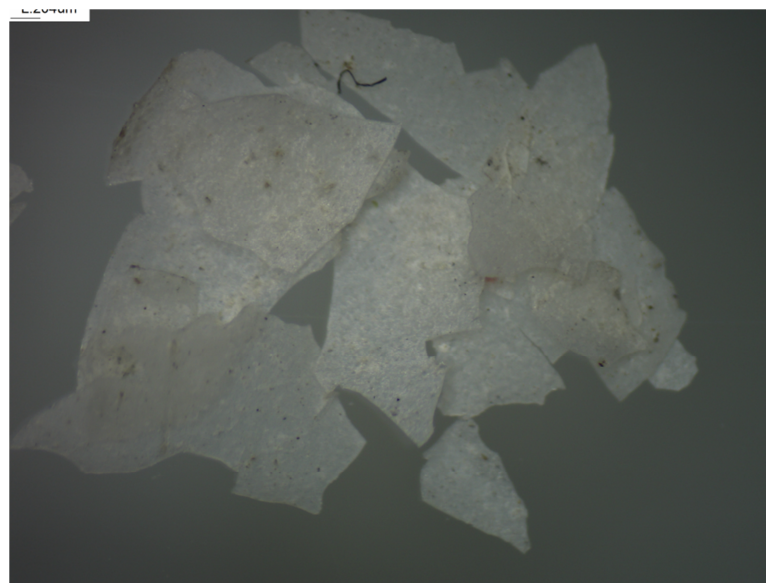
GP2 was collected from the coating applied by brush/roller on unpainted/painted surface (i.e. *d* layer of the GP1 sample), this whitish and fragile coating is flaking off (**fig.2**). FTIR-ATR spectrum has shown the characteristic absorption of an acrylic emulsion (probably p(*n*BA-MMA) confirmed by Py-GC-MS, with likely chalk and imaging analyses have allowed to highlight its presence and the bad state of conservation (flaking, cracking) (**fig. 3-4**).

**Fig. 2** “Two dragons carrying an egg (new creature)” –GP2 – SM –  
magnification 20 x

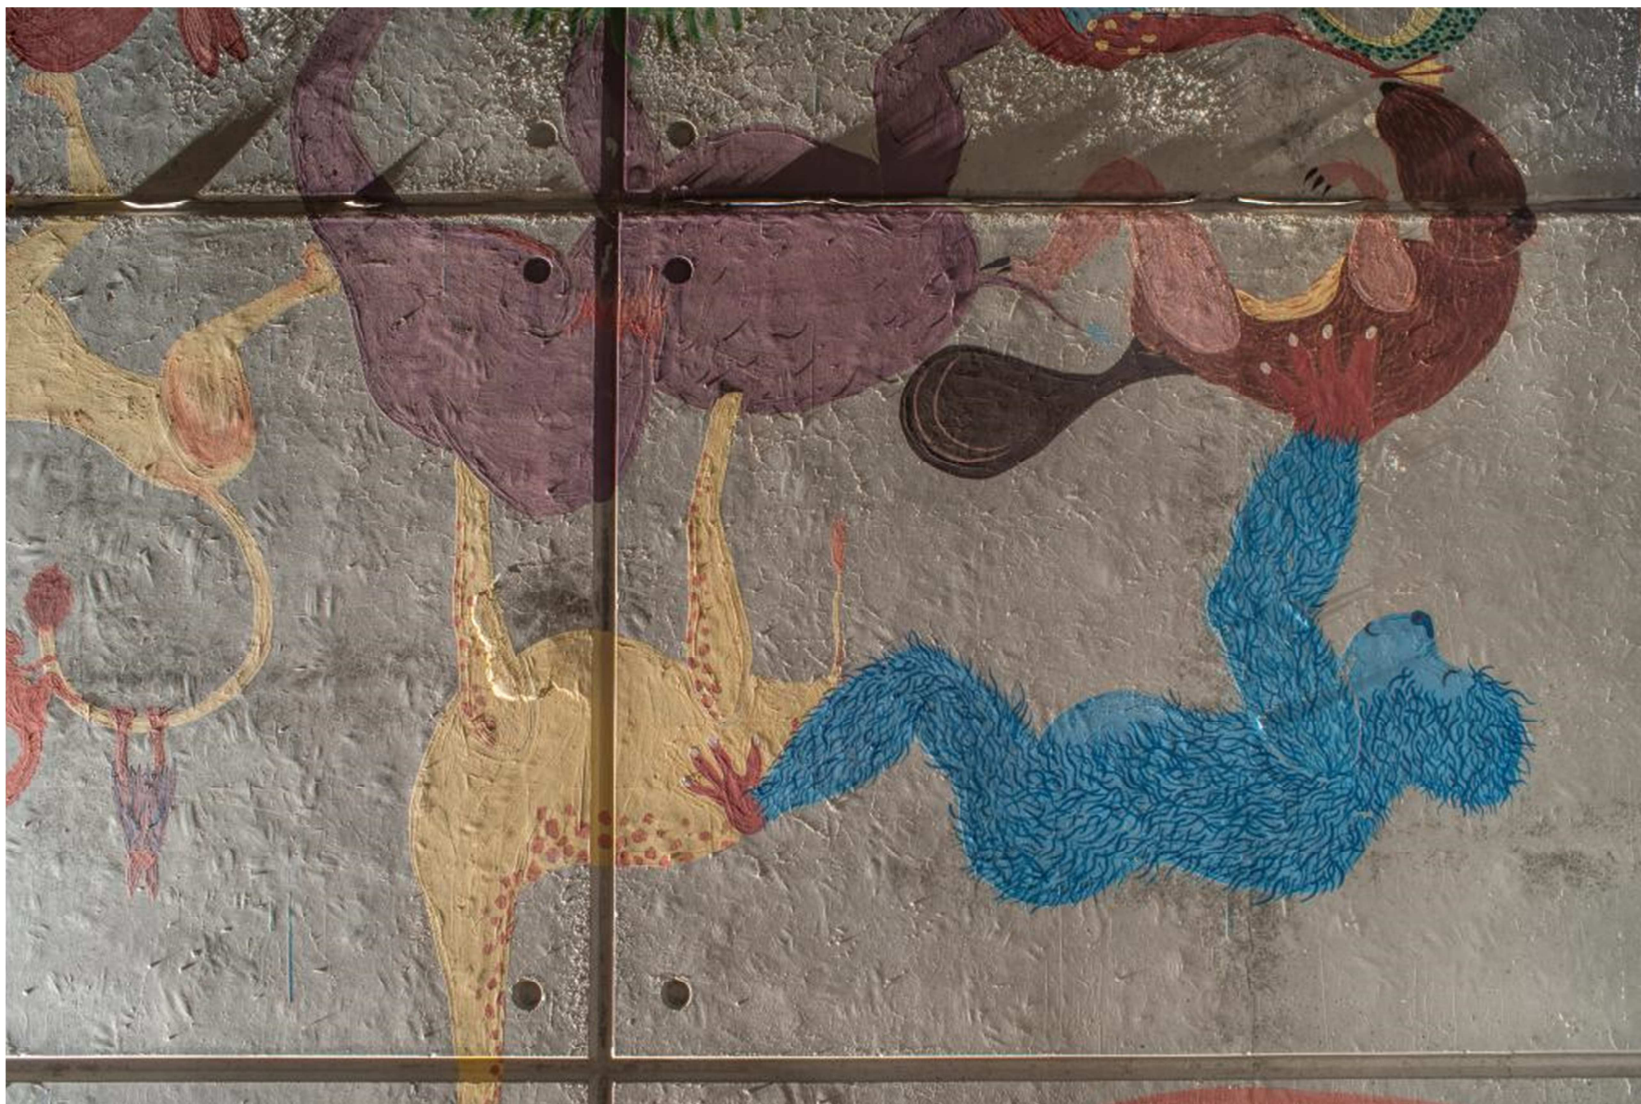
GP5 was taken several times during the 2019<sup>th</sup> year from a thin dark grey and compact patina that is spread on not pigmented areas of concrete support following a sort of grid and it is associated with cracks (**fig.3**). Analysis has shown a significant presence of filamentous fungi and yeast, being the black mould *Aureobasidium* the most dominant organism (**fig. 7-10**)

Fig. 3 "Two dragons carrying an egg (new creature)" – particular – digital photo under raking light

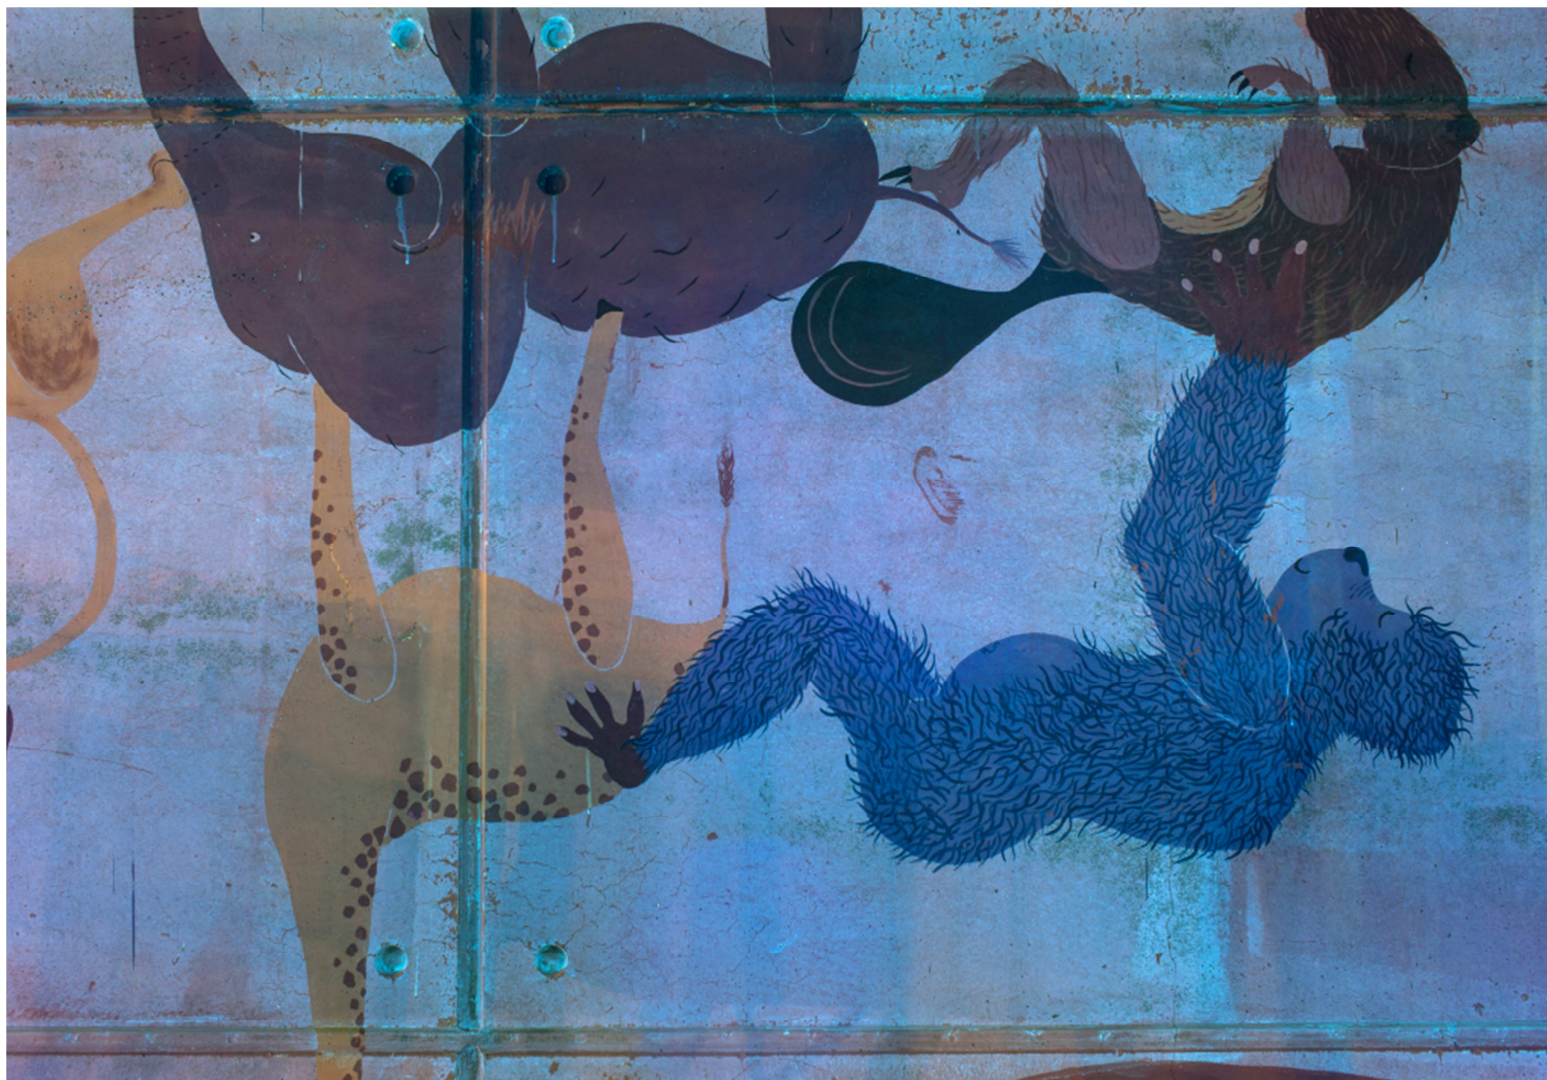
**Fig. 4** "Two dragons carrying an egg (new creature)" – particular – ultraviolet fluorescence photo

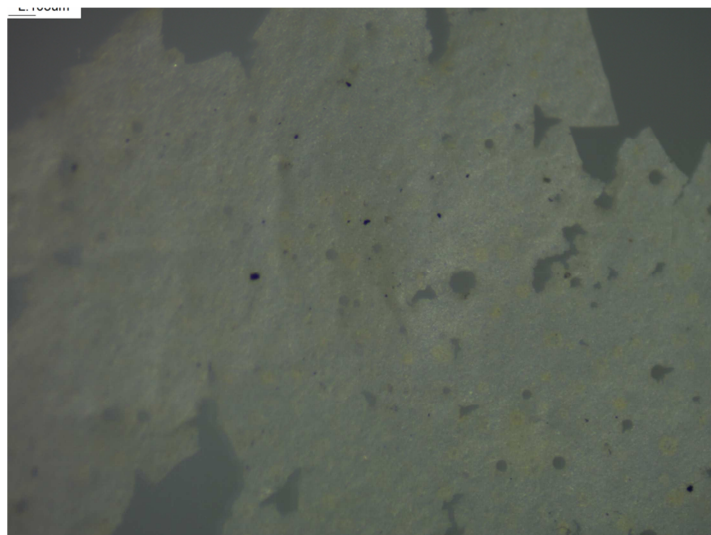
GP3 was collected from a fragile and flaked pale yellow (yellow-orange former) spray paint layer; it is detaching, together with the coating GP2 (**fig. 5**), from the pink paint layer applied below by brush (**fig. 6**). FTIR-ATR spectra have shown pattern of an acrylic resin for the yellow layer and alkyd-containing resin for the pink layer. Py-GC/Ms confirmed and better defines the two natures of the layers (styrene-acrylic for yellow layer and alkye alyer for the pink layer)

**Fig. 5** “Two dragons carrying an egg (new creature)” – sample GP3 – SM – magnification 40 x

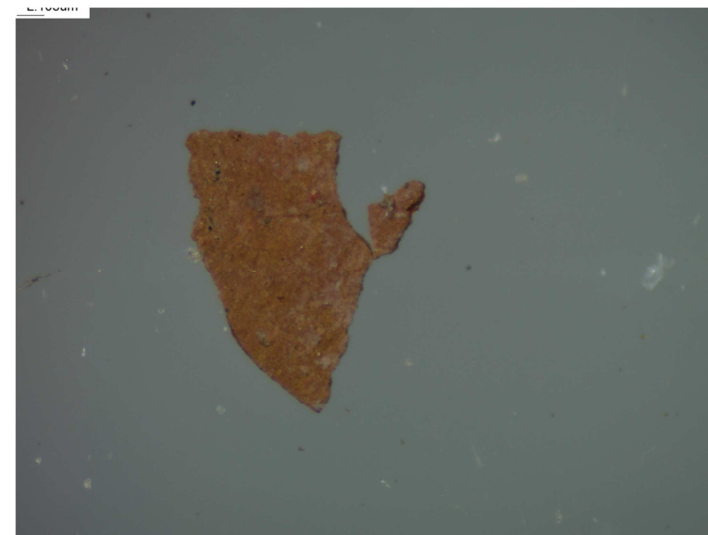
**Fig. 6** “Two dragons carrying an egg (new creature)” – sample GP3 – SM – magnification 40 x

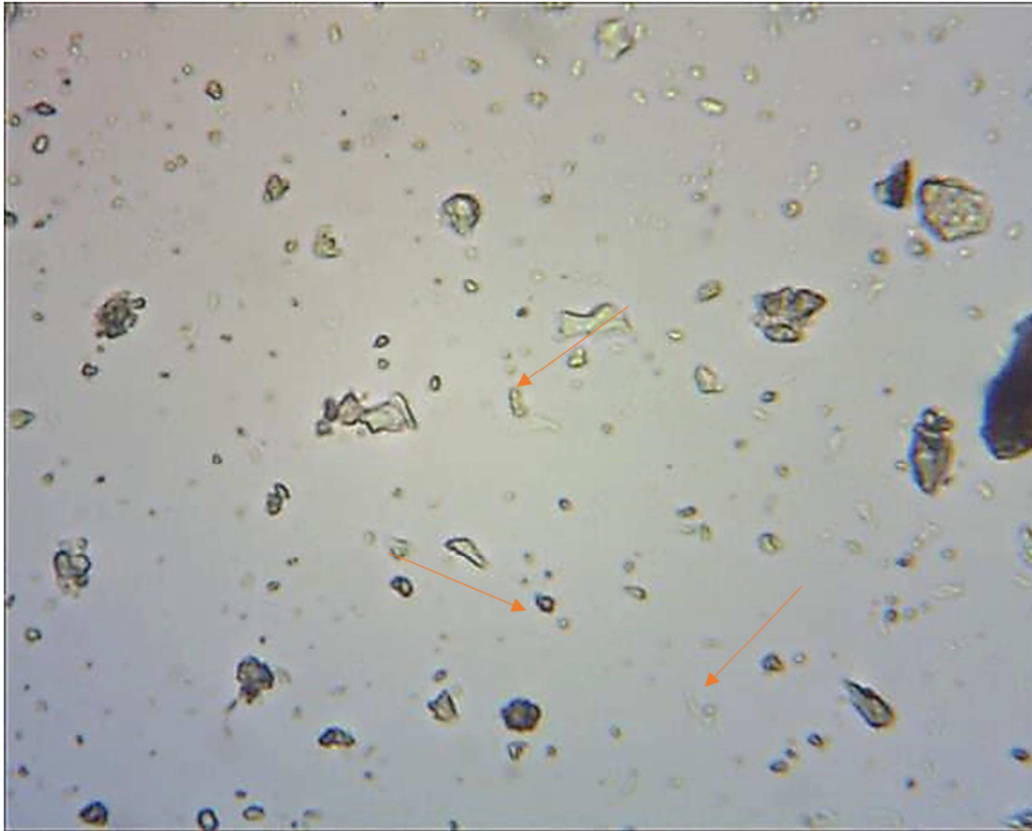
**Fig.7** "Two dragons carrying an egg (new creature)" – sample GP5 – transmitted Visible light – magnification 400x : erratic and motile spherical cells, sometimes present in 2-3 cells chain

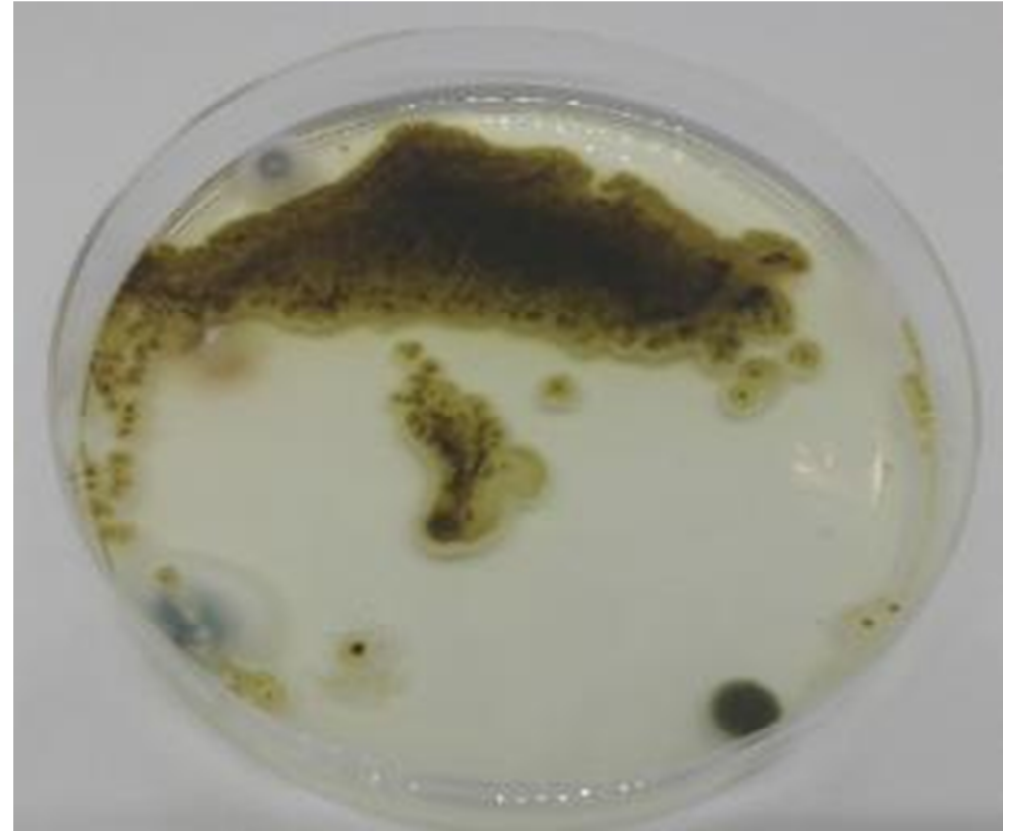
The presence of fungal species indicates the availability of organic substances on the surface of the cement wall.

**Fig. 8:** *Aureobasidium* colonies on agar plate from samples collected in July 2019

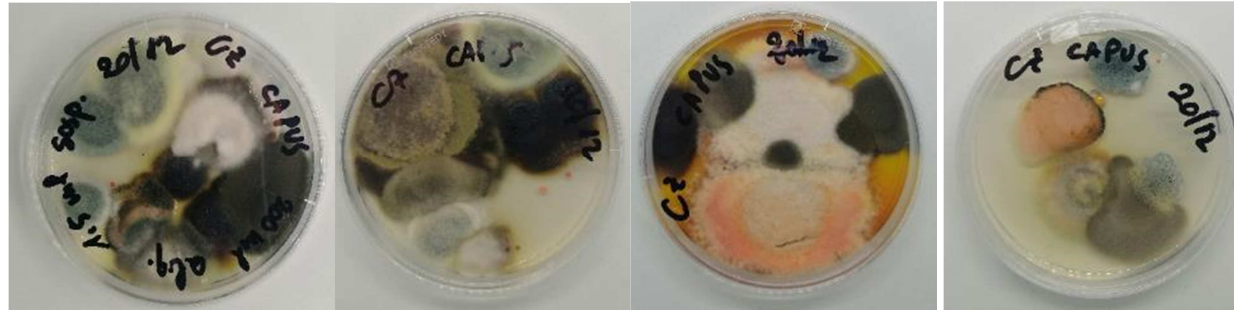
**Fig. 9.** Total CFU obtained on agar plates from samples collected in December 2019

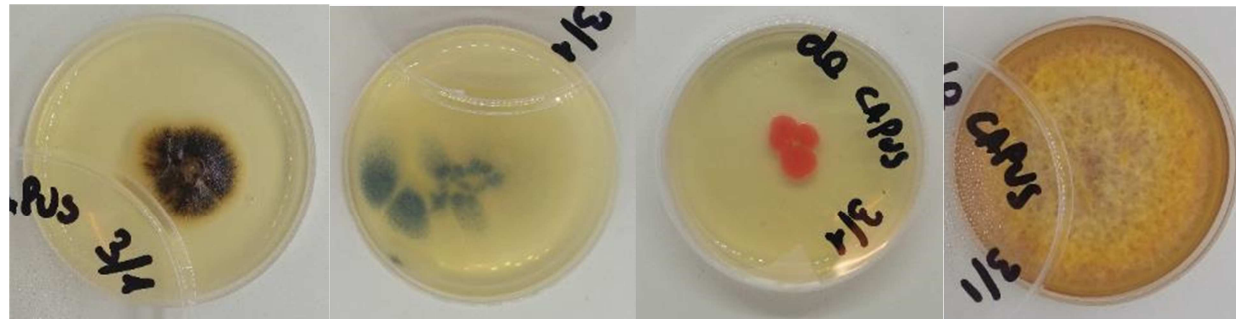
An investigation on concrete preparation techniques has highlighted the use of mineral oil for the detachment of concrete from molds. This procedure leaves in some surface areas dark patinas that could get harder and darker with aging. Probably this organic patina could be subsequently colonised by microorganisms, which enhance the surfaces darkening. In particular some fungal species such as *Aureobasidium*, *Epicoccum*, *Penicillium* and yeast such as *Rhodotorula* are known to effectively degrade mineral or vegetable oil. <sup>1,2,3,4</sup>

**Fig. 9** Co-dominant fungal species isolates (*Aureobasidium*, *Penicillium*, *Rhodotorula*, *Epicoccum*) from samples collected in December 2019
