CAPuS PROJECT - CONDITION REPORT

Artist	Ivan, Nais, Pao, Orticanoodles	 
Title of the work	Tribute to Mandela (UBUNTU) (ID OBJECT: 13a)	
Type of work	Mural	
Materials	spray and housepaint on wall	
Year of execution	2014	
Owner / custodian	Municipality of Milan	
Legal protection	-

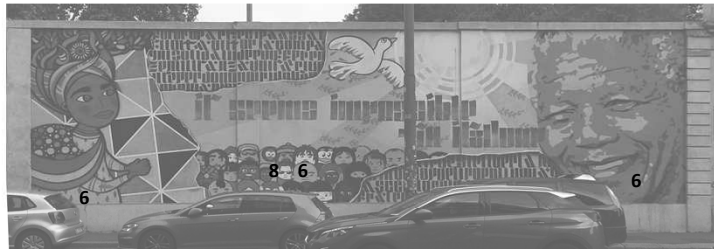
SURFACE - LOSS OF COHESION

- 1 COLLAPSE
- 2 LOSS OF COHESION
- 3 CRUMBLING
- 4 INCISION
- 5 FRACTURE
- 6 **CRACKING**
- 7 OPEN JOINT
- 8 **DELAMINATION**
- 9 FLAKING
- 10 SCALING

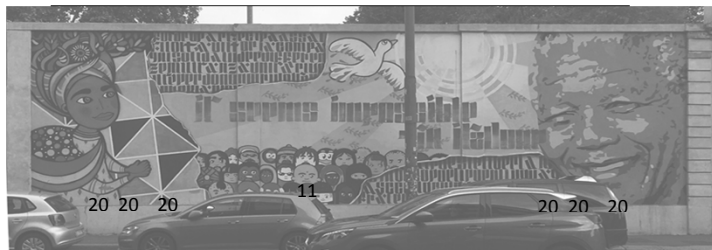
SURFACE - LOSS OF MATERIAL

- 11 **LOSS**
- 12 LACUNA
- 13 EROSION
- 14 ABRASION
- 15 ROUNDED/ROUNDING
- 16 PERFORATION
- 17 PITTING
- 18 CAVITY
- 19 ALVEOLIZATION
- 20 **SCRATCH**
- 21 ROUGHENED/ROUGHENING

NOTES THE WALL SUFFERED OF DECOHESION BEFORE THE PAINTING HAD BEEN REALIZED (COLOR INTO LACUNAS)
