CAPUS PROJECT - CONDITION REPORT

Artist(s)	BIGTATO, JOES, PIOVE, WENS, IBS							
Title of the work	"We Love Enak 2011"							
Type of work	Mural painting							
Materials	Spray paint, bricks							
Year of execution	2011							
Owner / custodian	Municipality of Turin							
Legal protection

This condition report is referred to the portion of graffiti "Sayo"

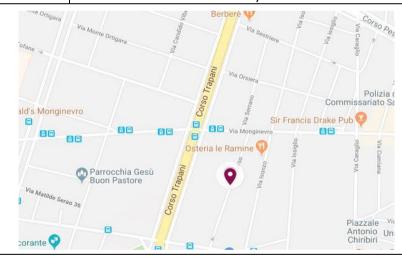
Dimensions (cm)									
Height	Width	Depth							
300	1000								
Country	lta	Italy							
City	Turin								
Address		Via Carso (De Valle's Garden)							
GPS coordinates									
Latitude	45°03'	47.5"N							
Longitud	e 7°38'	7°38'15.9"E
