Object 1. *Entaraña*-LIOEN-Vigo 2008

Characterization of MATERIALS-SUPPORT – January 2020

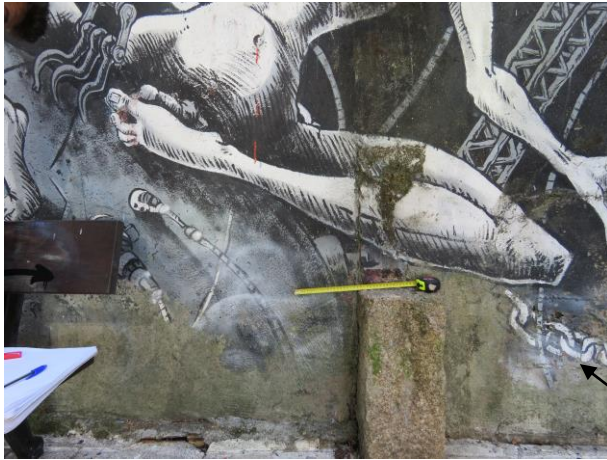
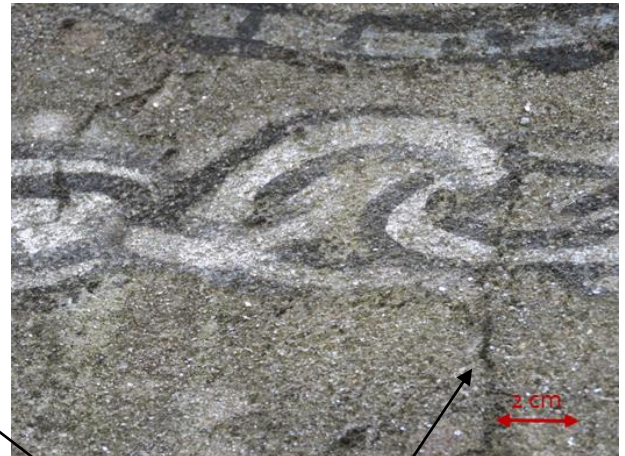
DESCRIPTION	Concrete render on brick wall (upper part) Exposed reinforced concrete Wall (bottom) Northwest (N40W) facing wall
ANALYSIS	x-ray diffraction SEM-EDS
RESULTS	COMPOSITION Aggregate –silicate Cement phase-Portland cement with fly ash CONSERVATION STATE Highly porous Carbonated
